HYDROGEOLOGIC EVALUATION
OF THE
PONCE CENTER FOR ENVIRONMENTAL CONTROL SITE
PONCE, PUERTO RICO

U.S. Environmental Protection Agency
Region II
New York, New York

The Earth Technology Corporation
500 Elizabeth Avenue, Suite 100
Somerset, New Jersey 08873

13 August 1984

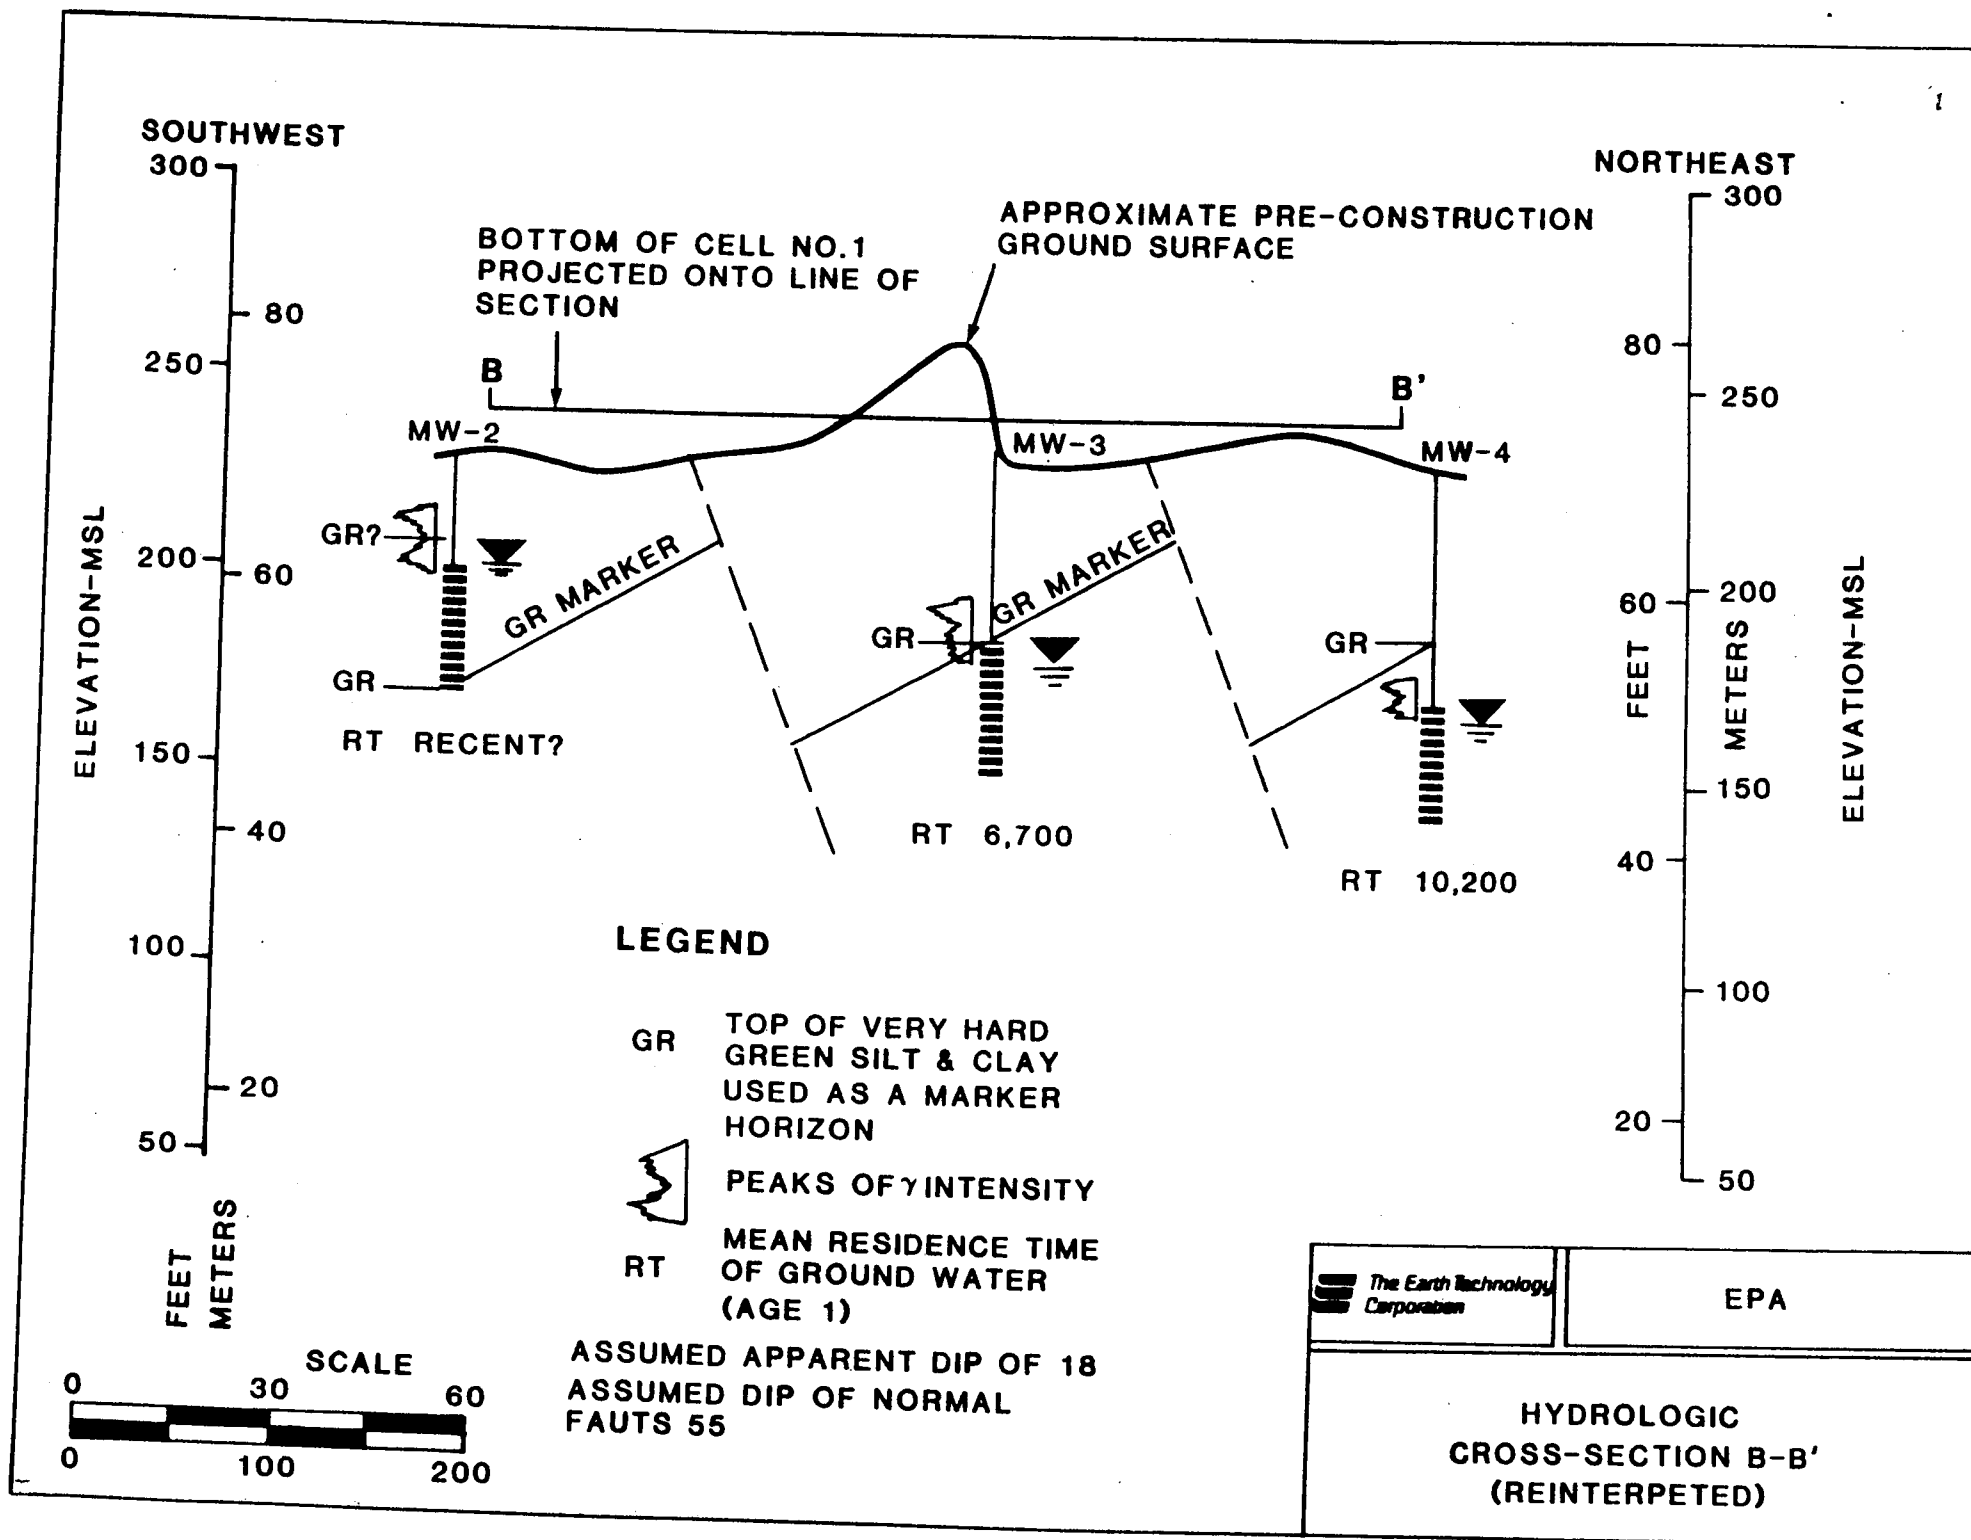
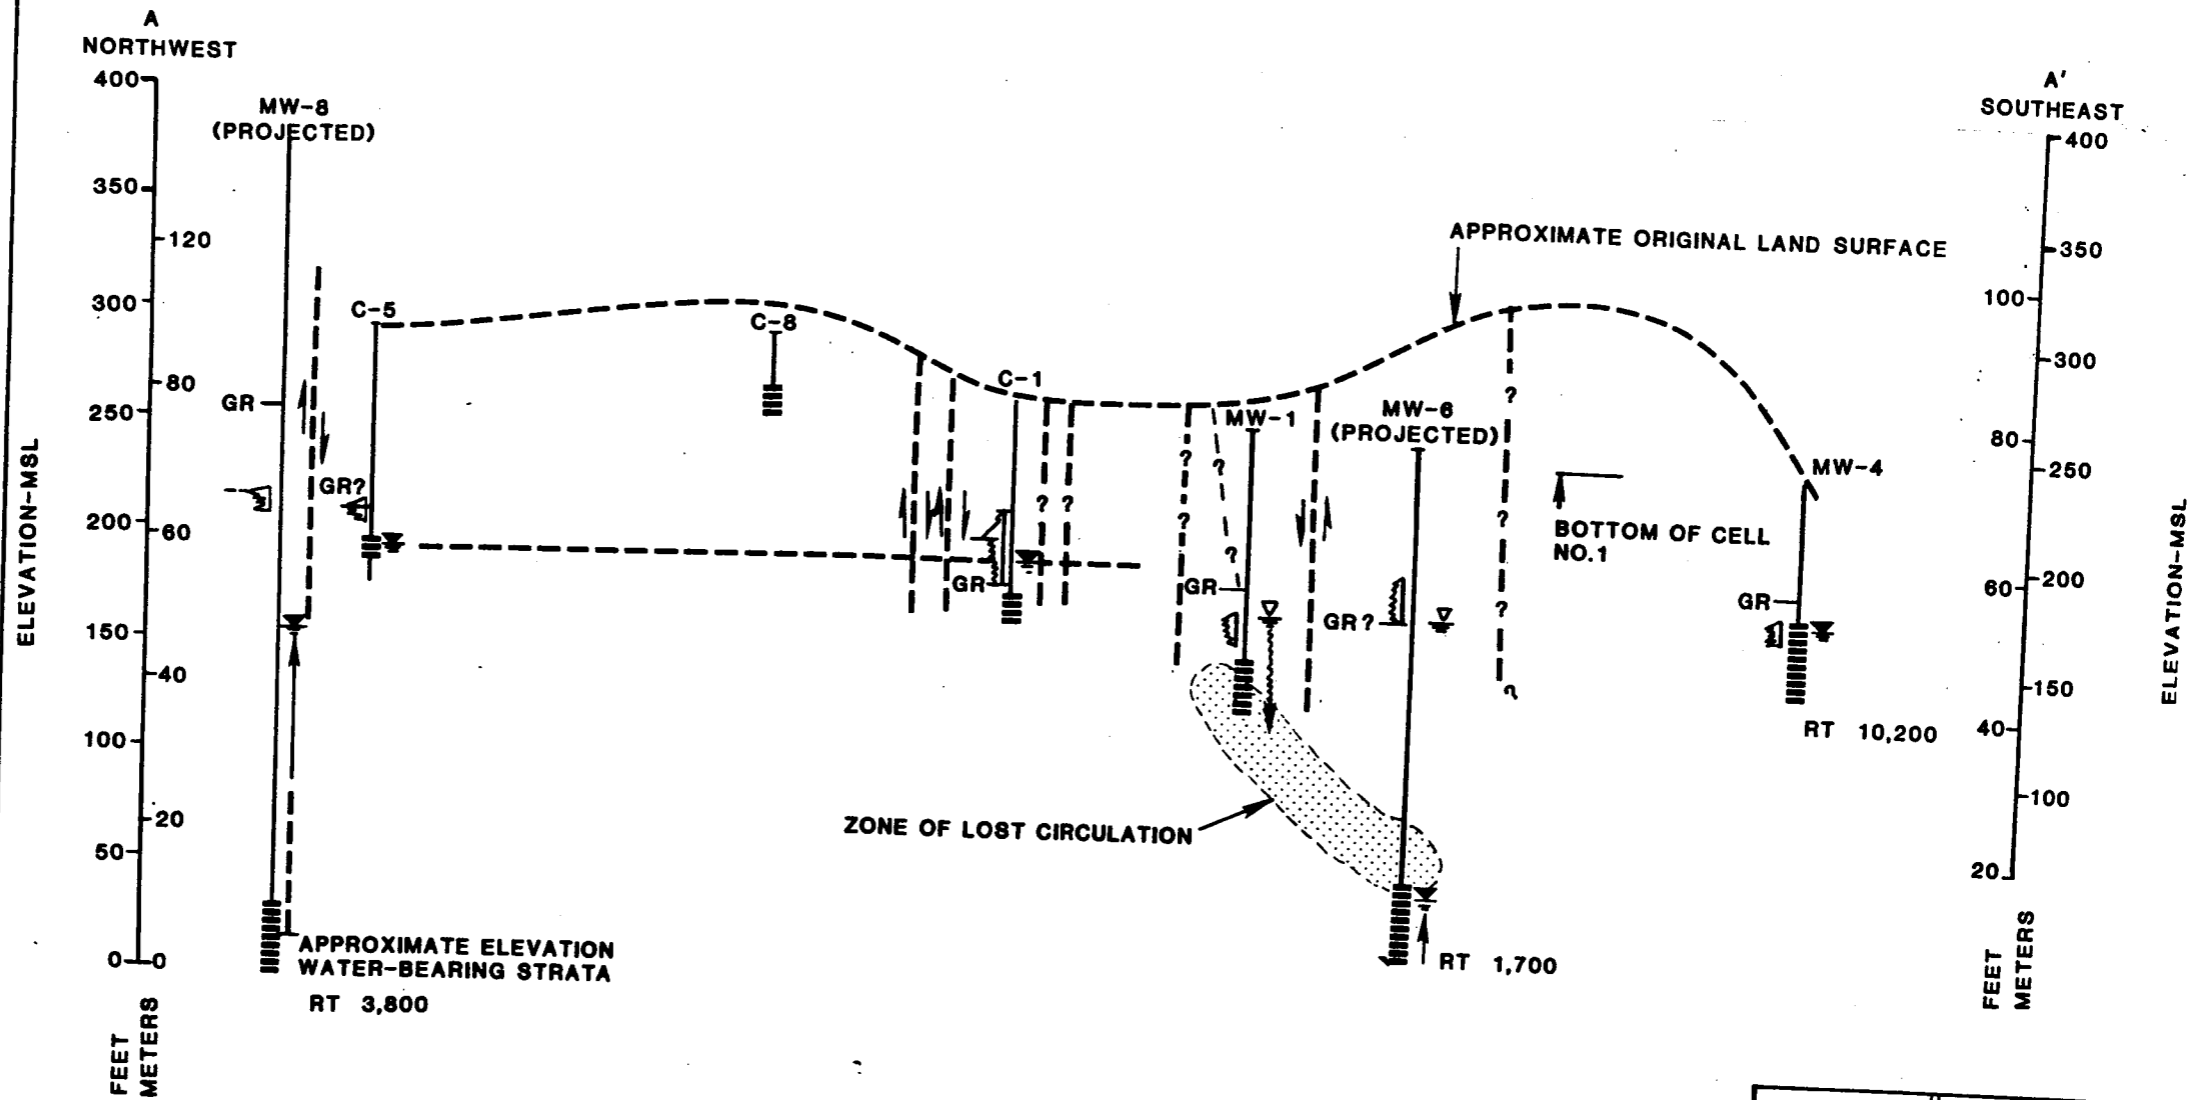
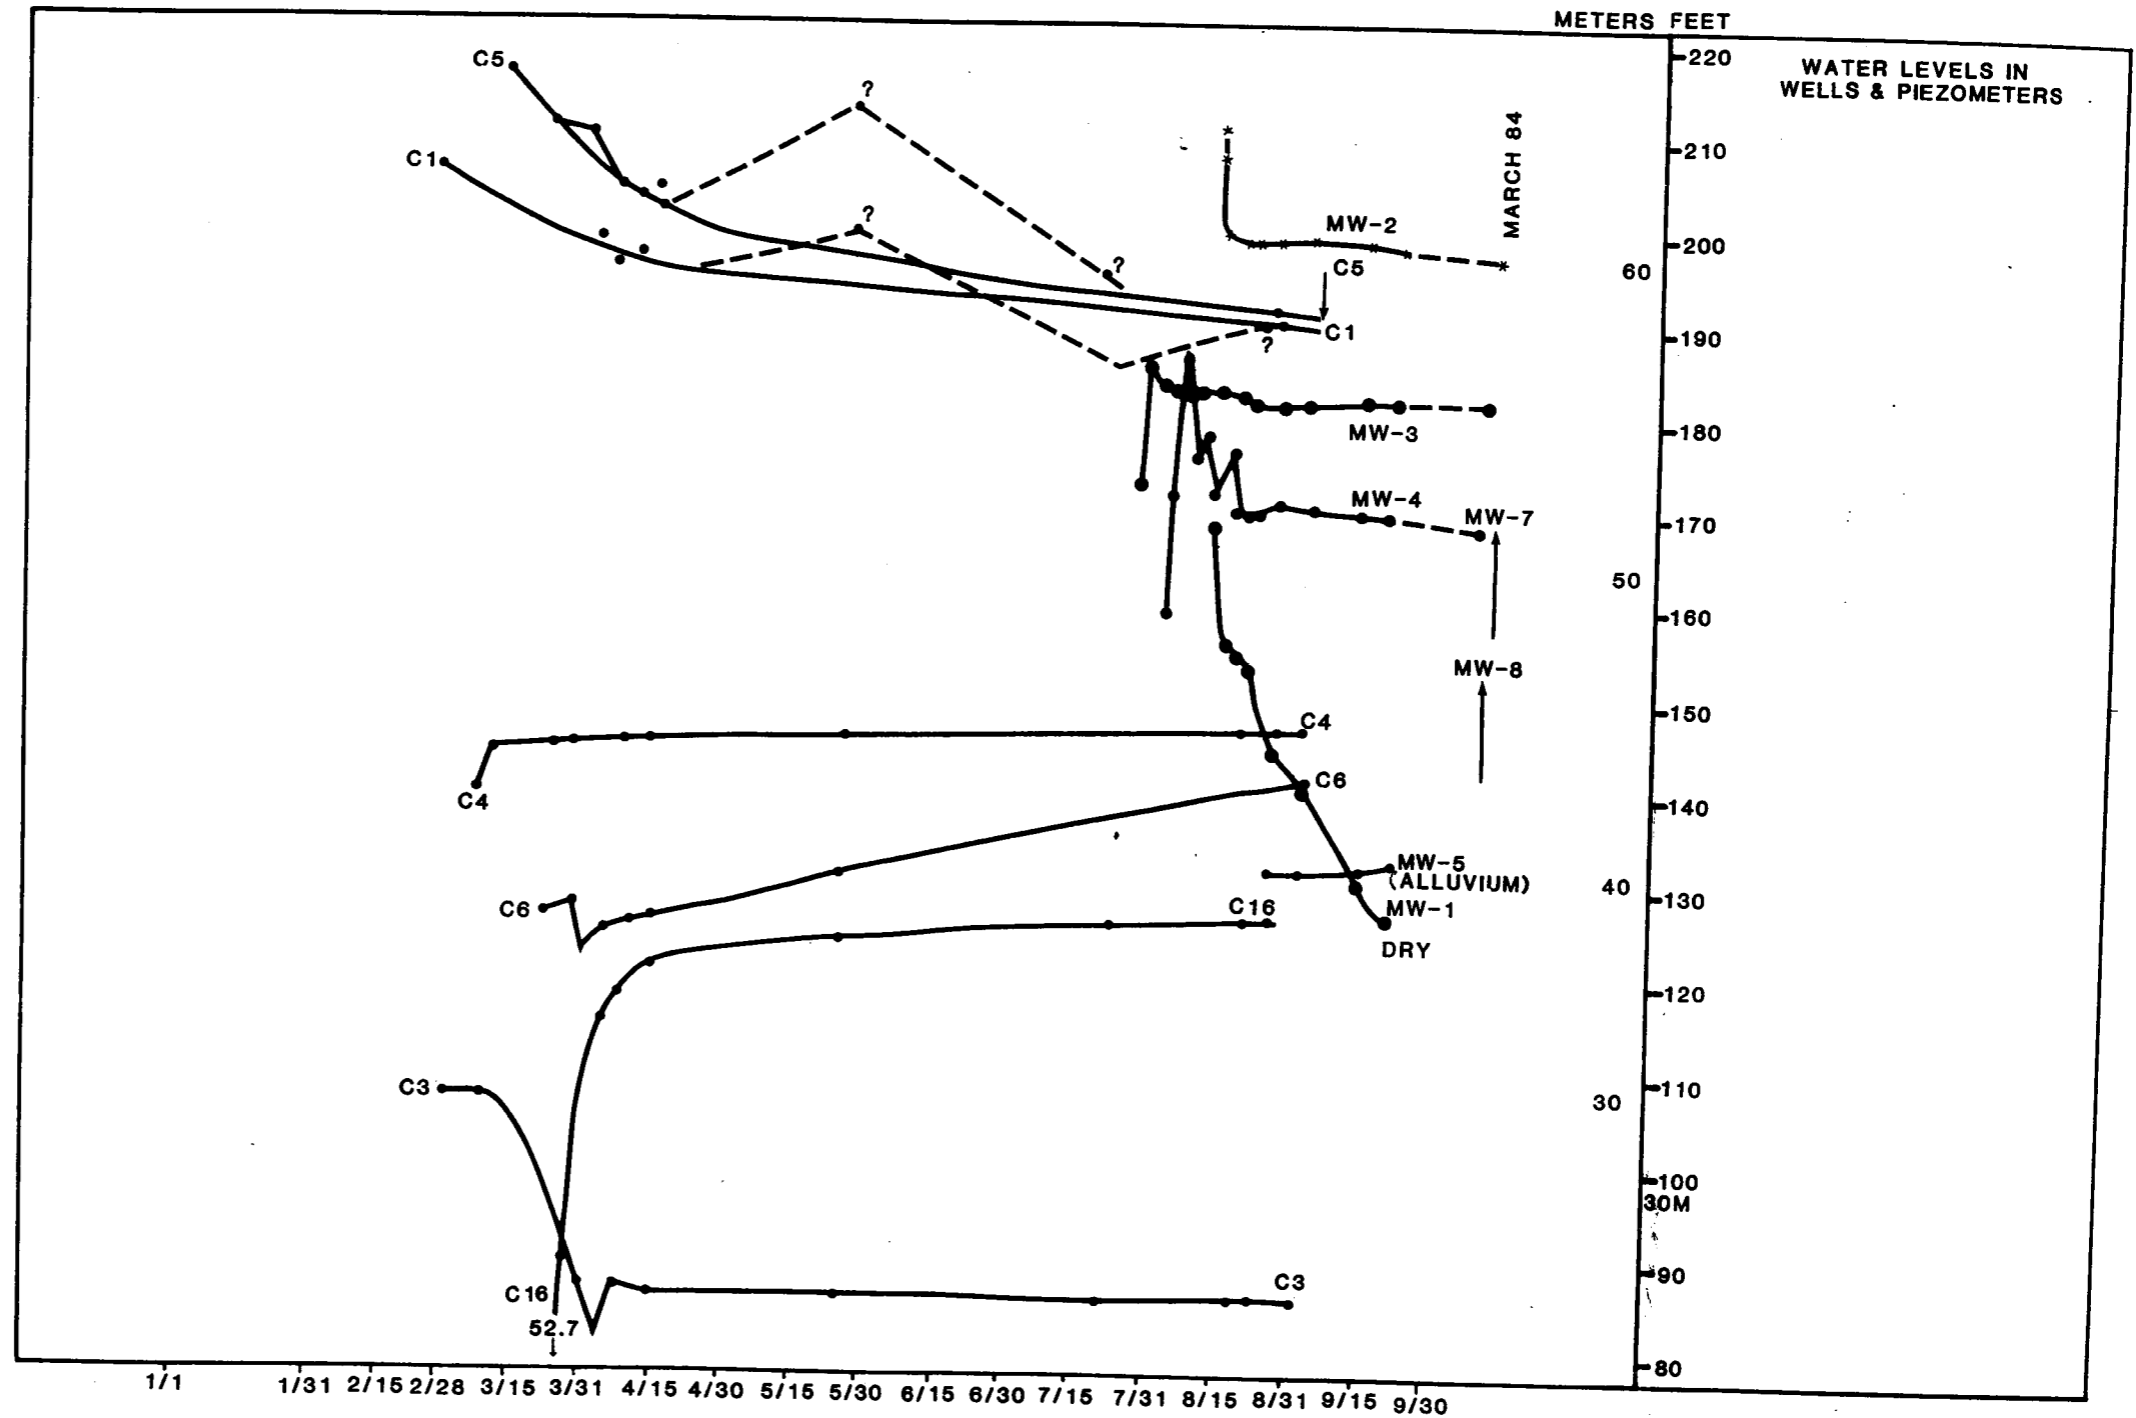
FIGURES

Adapted from work completed by Law Engineering Testing, Co.

Abnormal behavior of the graph for MW-1 is very distinct and indicative of more than one water-bearing zone in the well vicinity. Drilling and screening of MW-1 partly in a more pervious fracture zone (fluid loss) appears to have resulted in drainage of water from the upper zone down through the fracture zone which was detected also in MW-6 (see Section A-A').
